# Manhole Inspection Summary

Manhole # S15CC2013MH

Insp Date: **7/26/06 11:48 AM**

**Location** Address: **2007 SULGRAVE RD**

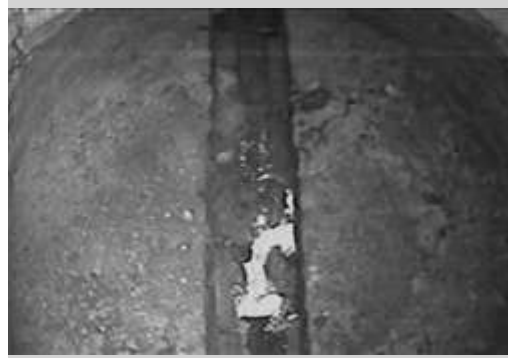
Top View

Bench and Channel debris.

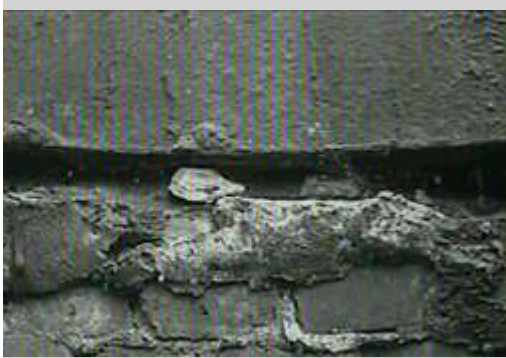
Defect

**Frame** Offset: **0** (in.) Condition: ☐ Sound ☐ Cracked ☒ **Leaks**

Condition: ☐ Sound ☐ Cracked ☐ Root Intrusion ☐ Loose Brick ☒ **Deteriorated**

Infiltration: ☐ None ☒ **Joint** ☐ Cracks ☒ **Mortar** ☐ Roots ☐ Wall

Frame leaks. Adjustment deterioration and infiltration.

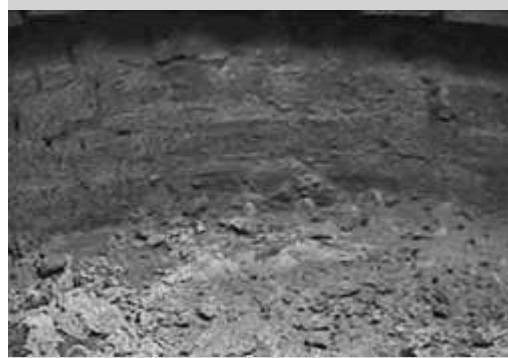
Defect

Bench debris.
